STATE OF CALIFORNIA SPECIAL STUDIES ZONES

RITTER RIDGE QUADRANGLE

OFFICIAL MAP

Effective: July 1, 1974

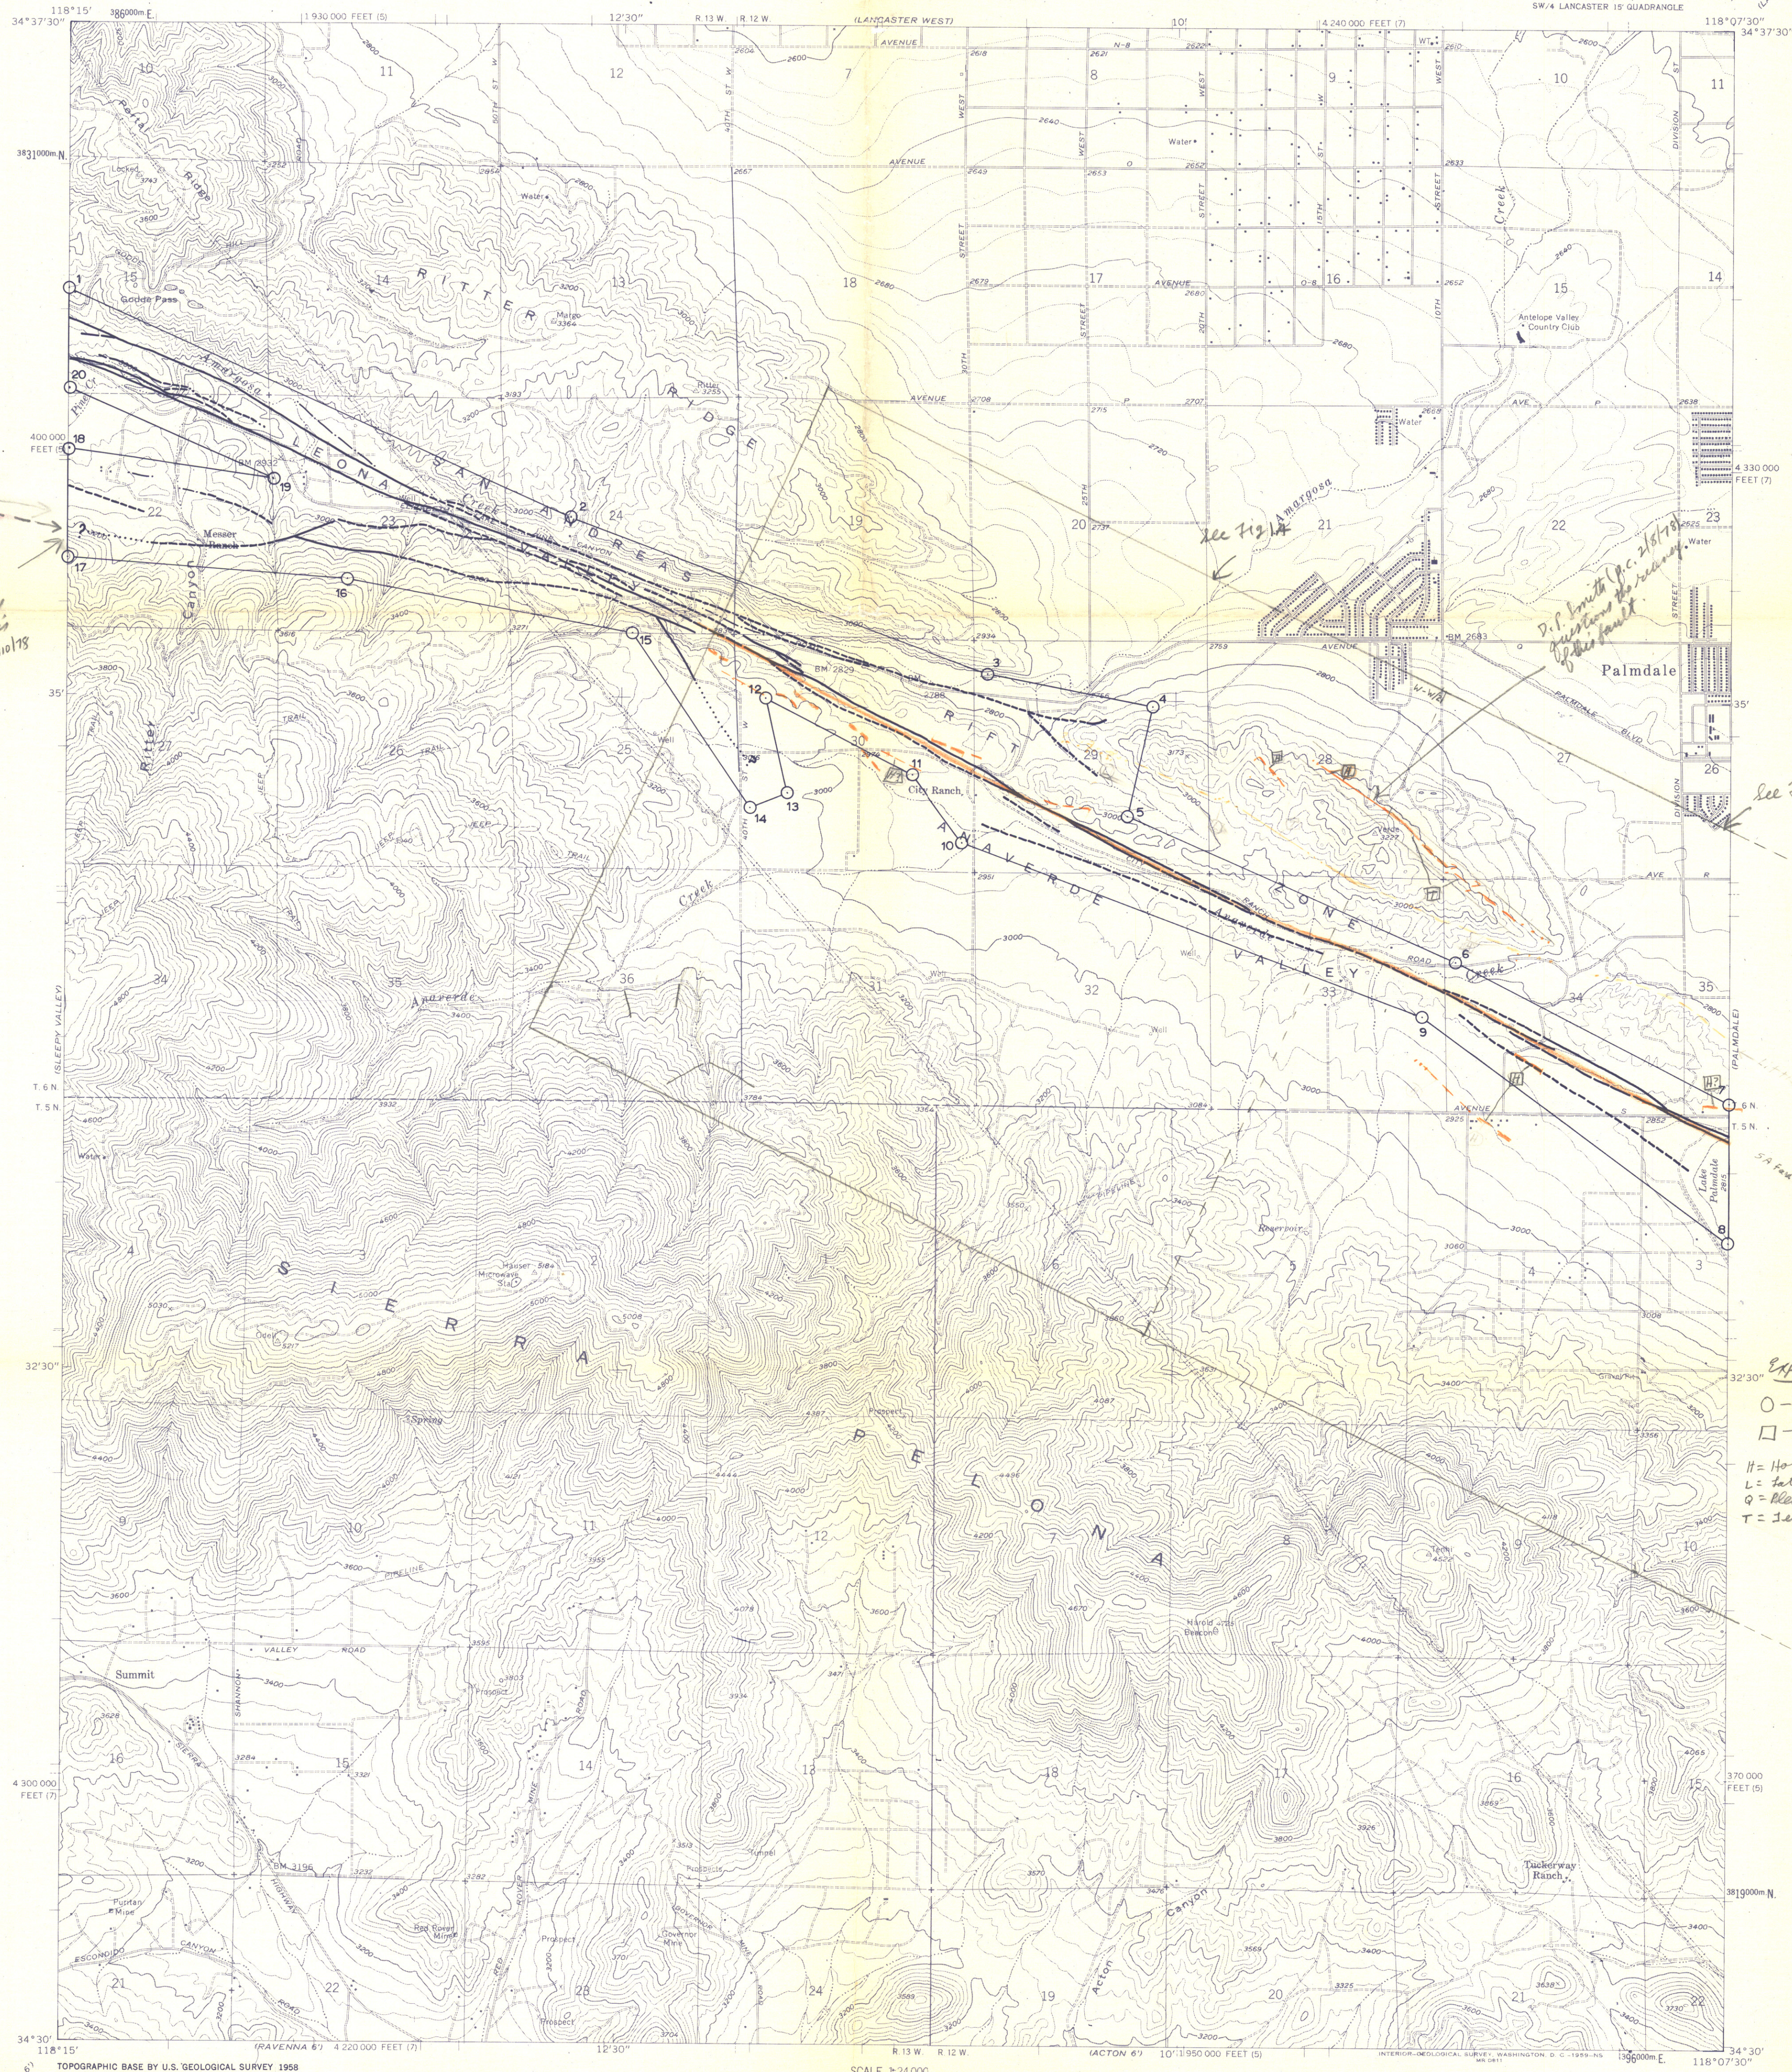
Faults considered to have been active during Quaternary time; solid line where accurately located, long dash where approximately located, short dash where inferred, dotted where concealed; query (?) indicates additional uncertainty. Evidence of historic offset indicated by year of earthquake-associated event or C for displacement caused by creep or possible creep.

Aerial photo lineaments (not field checked); based on youthful geomorphic and other features believed to be the results of Quaternary faulting.

These are delineated as straight-line segments that connect consecutively numbered turning points so as to define one or more special studies zone segments.
